BIKE	HONDA CBR 1000 RR	PART NO.	HA-1001
YEAR	2012 - 13	FIT KITS	Z039.20451
NOTES	Bung and copper washer to be replaced by OE lambda probe. (not applicable to non catalyst models), nylon washer either side of item 9.	FEATURES	DB KILLER Z028.20173(Z)

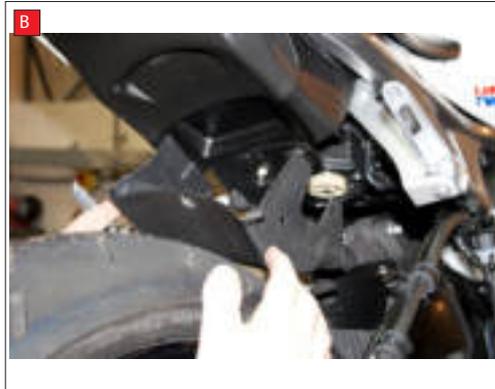
B) Remove back panel to allow access to servo wheel.

C) Turn servo wheel 45° clockwise, this make the cable easier to remove.

D) Remove the cable from the clip at the back of the servo wheel unit.

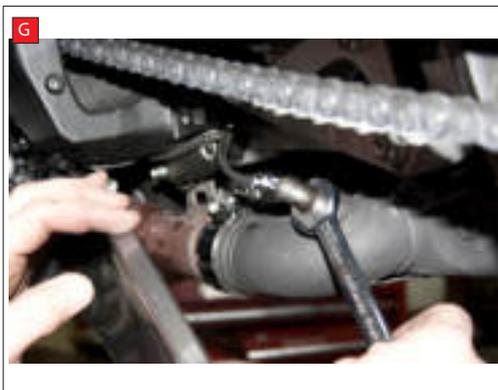
G) Remove Lambda sensor (if bike is fitted with one)

H) Loosen O.E clamp to free the O.E exhaust from O.E system.

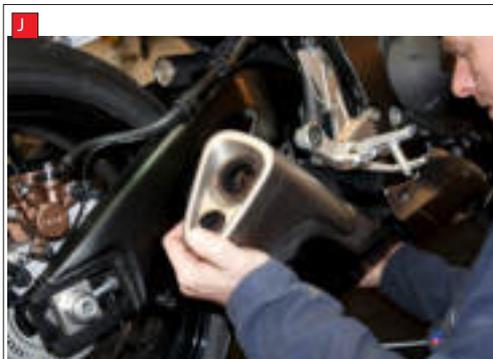
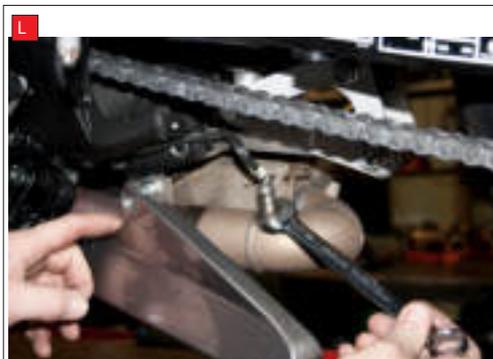
I) Remove O.E silencer mounting bolt, keep this bolt as it will be needed later on in fitting Scorpion Exhaust.

J) Slowly remove the O.E exhaust - take care with feeding out the servo cable.

K) Introduce the connecting box CP668 up to the O.E system, DO NOT tighten up the clamp.

L) Put the Lambda sensor into the CP668, if no lambda sensor is on bike then leave in blanking plug, make sure the Lambda or blanking plug is tight.

M) Bolt on the Scorpion mounting bracket using the O.E mounting bolt, DO NOT FULLY TIGHTEN.

N) Fit Scorpion silencer to CP668, position strap and rubber and bolt to the mounting bracket. tighten up both bolts and attach the 2 x rubber coated springs.

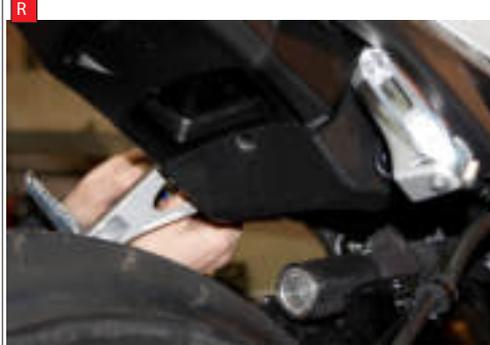
Q) Fit the Scorpion composite fairing, using the line drawing on page 1 to make sure all the fixings are in the correct place, on the top mounting point on the fairing use the O.E bolt.

R) Bolt back the 2 x plastic panels that hid the servo wheel.
